Balcony Inspection Report & Certification

Property / Establishment Name: FIORE AT THE GARDENS

Report Date: 9/20/25

Prepared By (Inspector): Andre H. Thomas, P.E. CGC

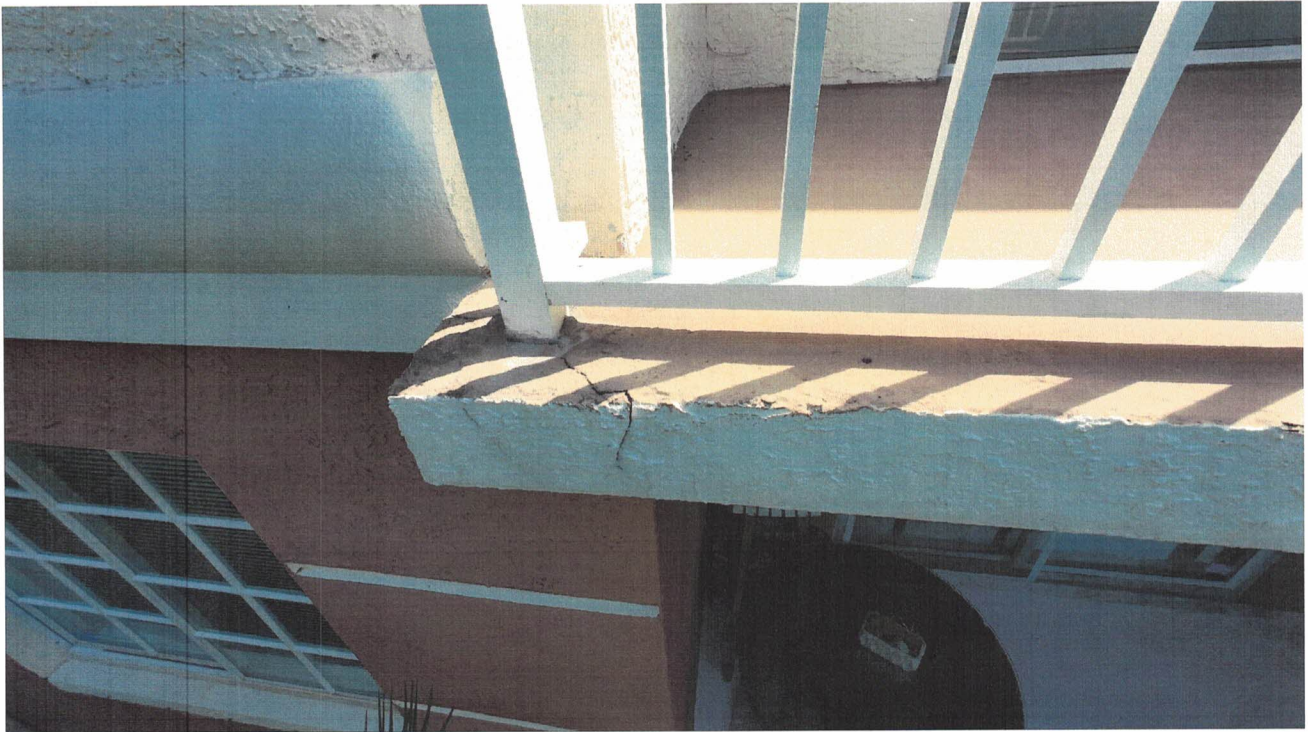
Unit 1212 - Spalling at corner post

- For Units designated with a No. 4 shall be repaired immediately to avoid further damage to the balcony and potentially compromise the integrity of the balcony handrail.

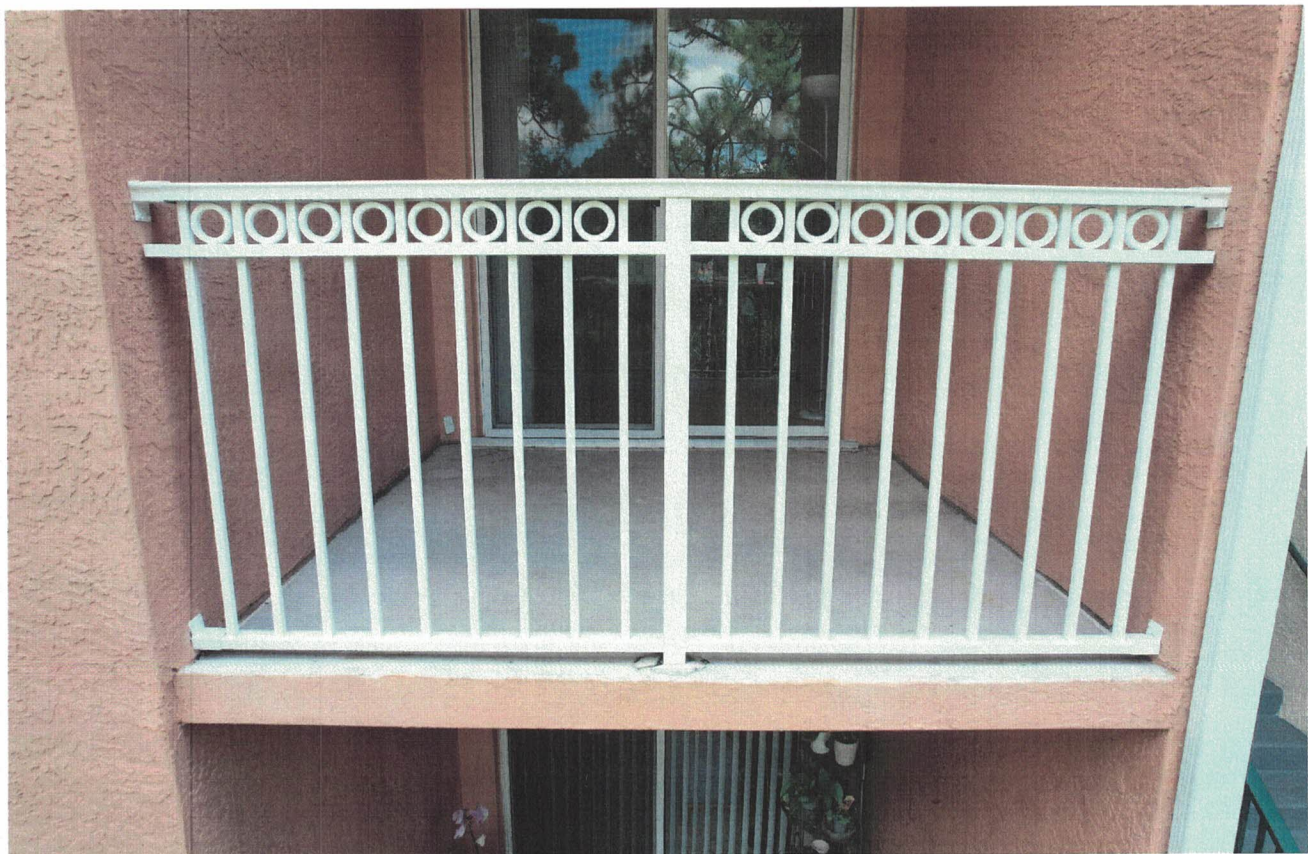
Unit 1210 - Grout spalling around base of post

- For Units designated with a No. 2 shall have the spalled area or exposed rebar coated using an epoxy-based grout.
- For Units designated with a No. 3 shall be inspected every 6 months by a competent person to confirm cracks are dormant. Penetrant Sealant and/or Epoxy Injection may be used to seal cracks that are considered dormant.

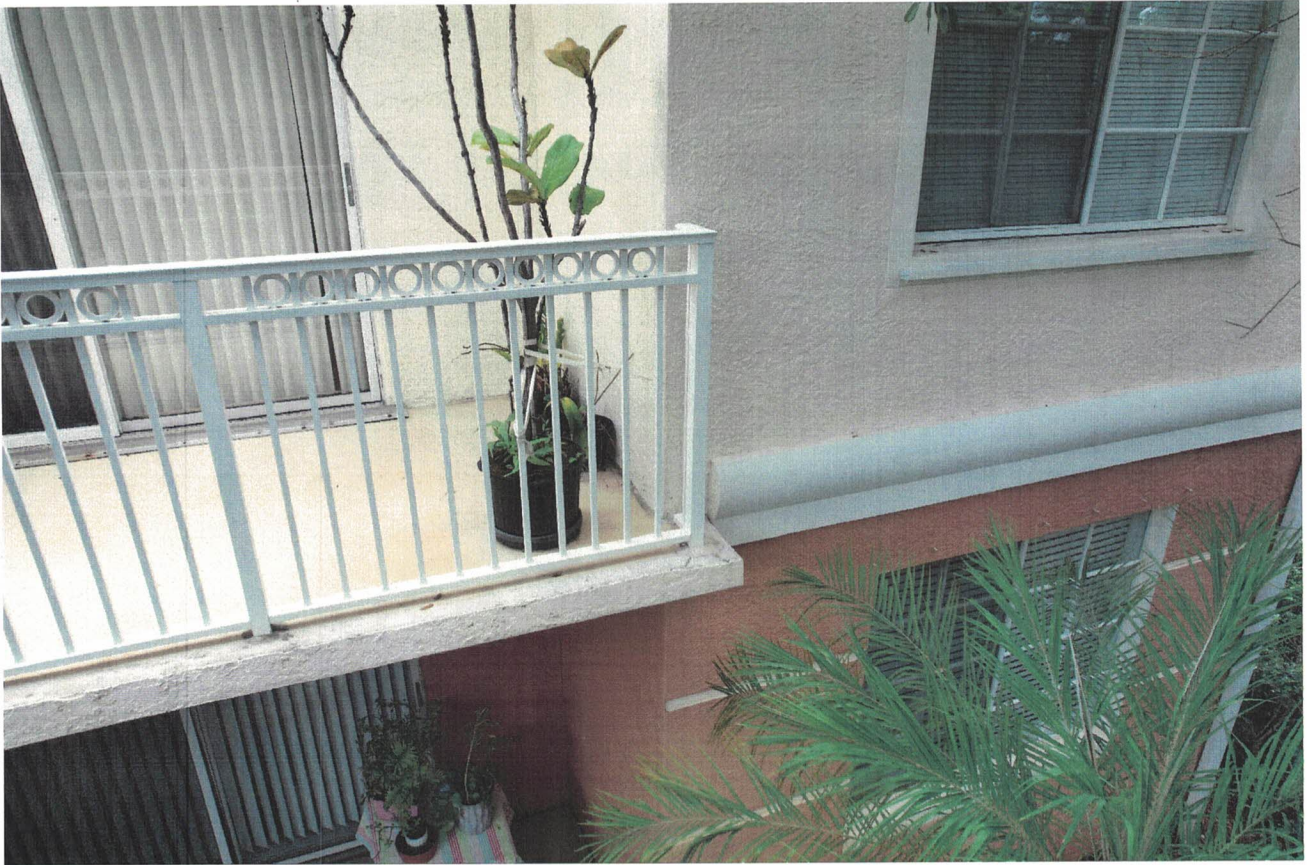
Unit 1202 - Light cracks on the corner edge

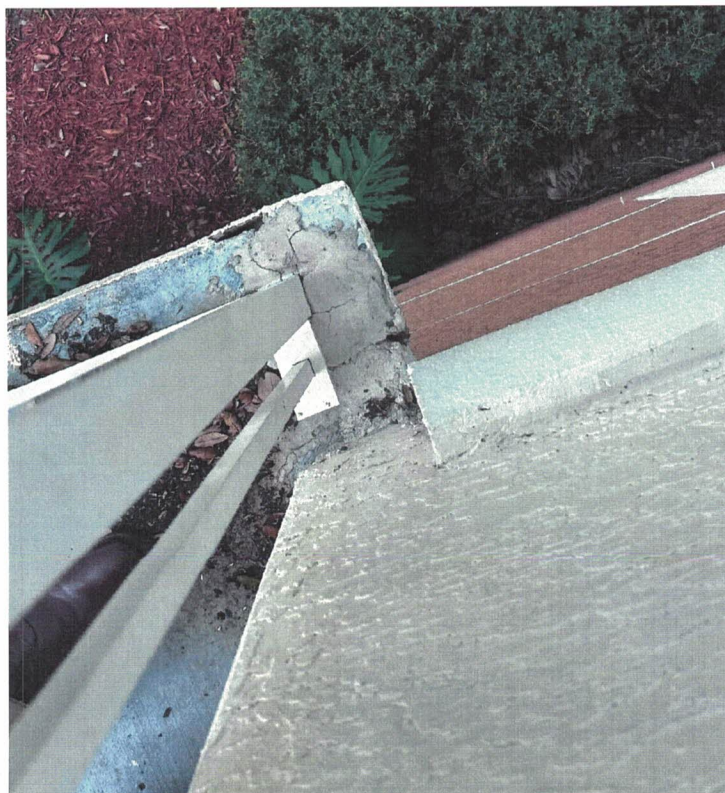
Unit 2212 - Spalling at corner post

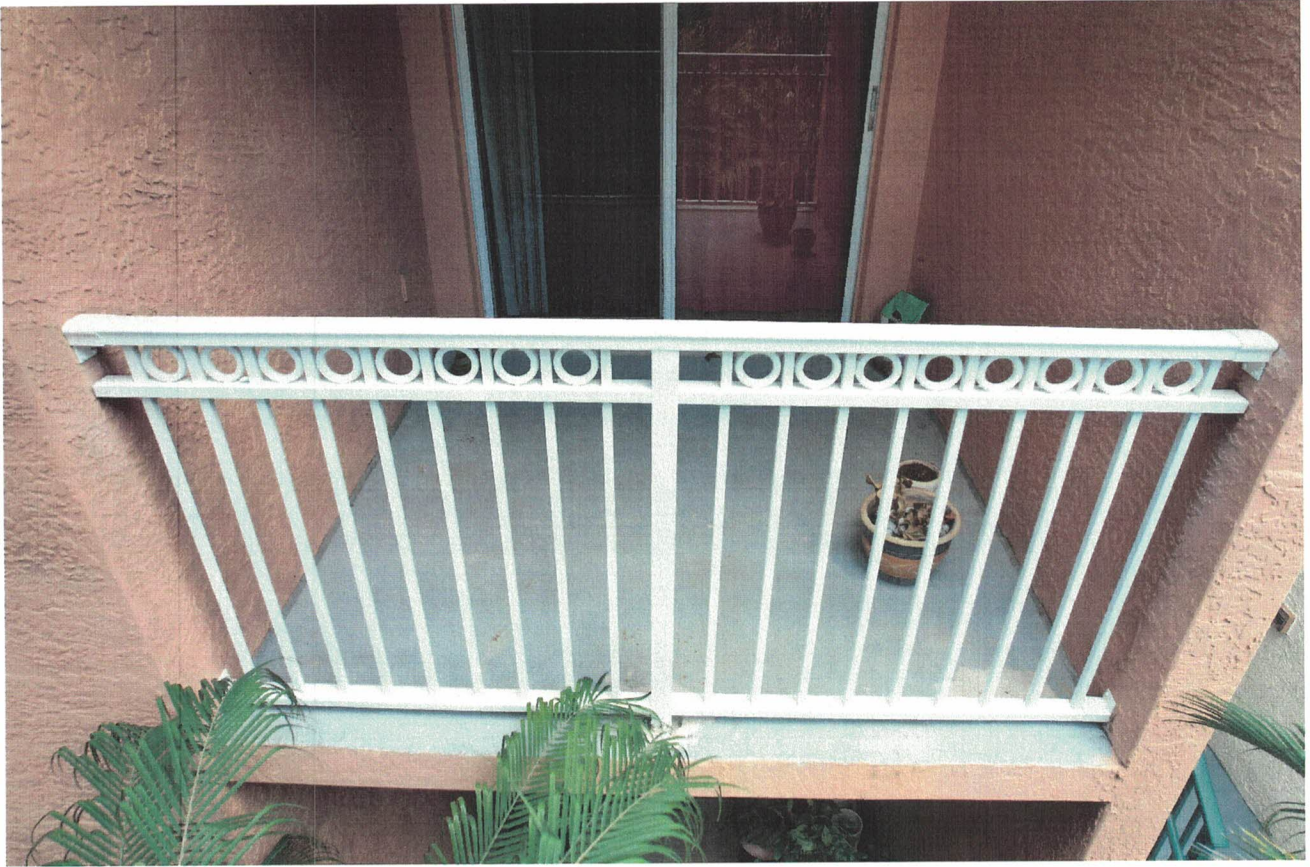
Unit 2206 - Grout missing at base of post

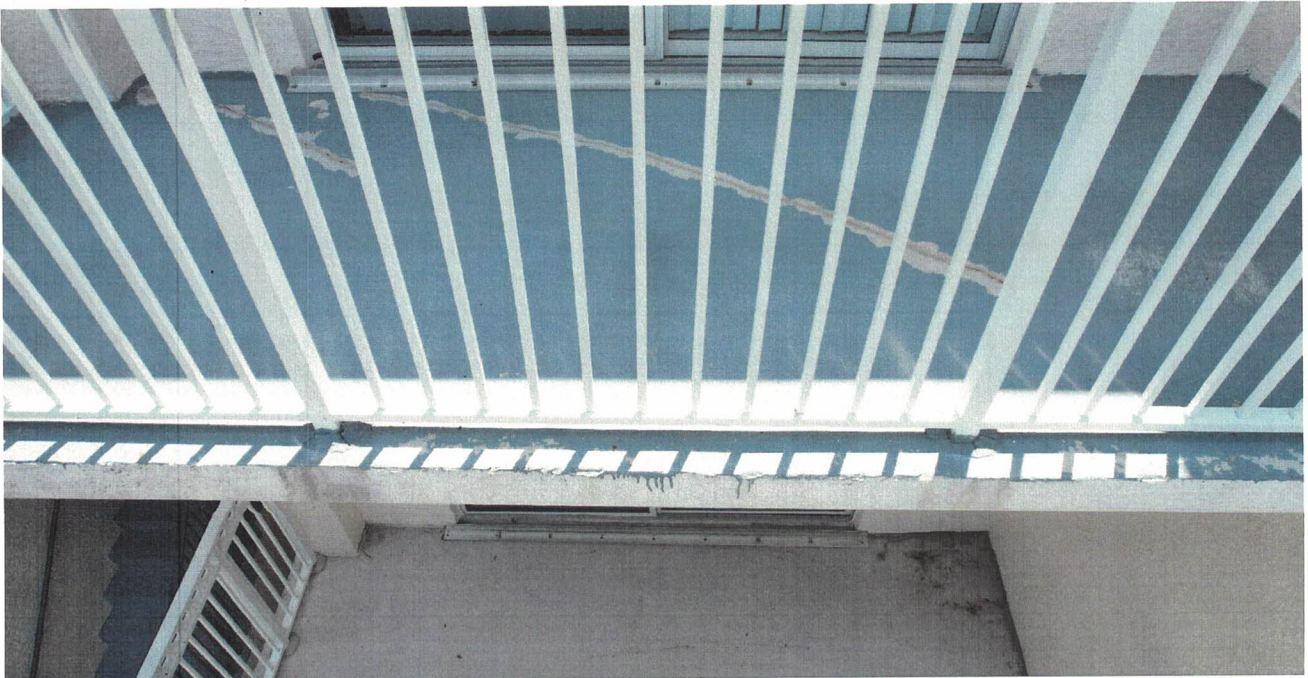
Unit 3304 - Long cracks along slab

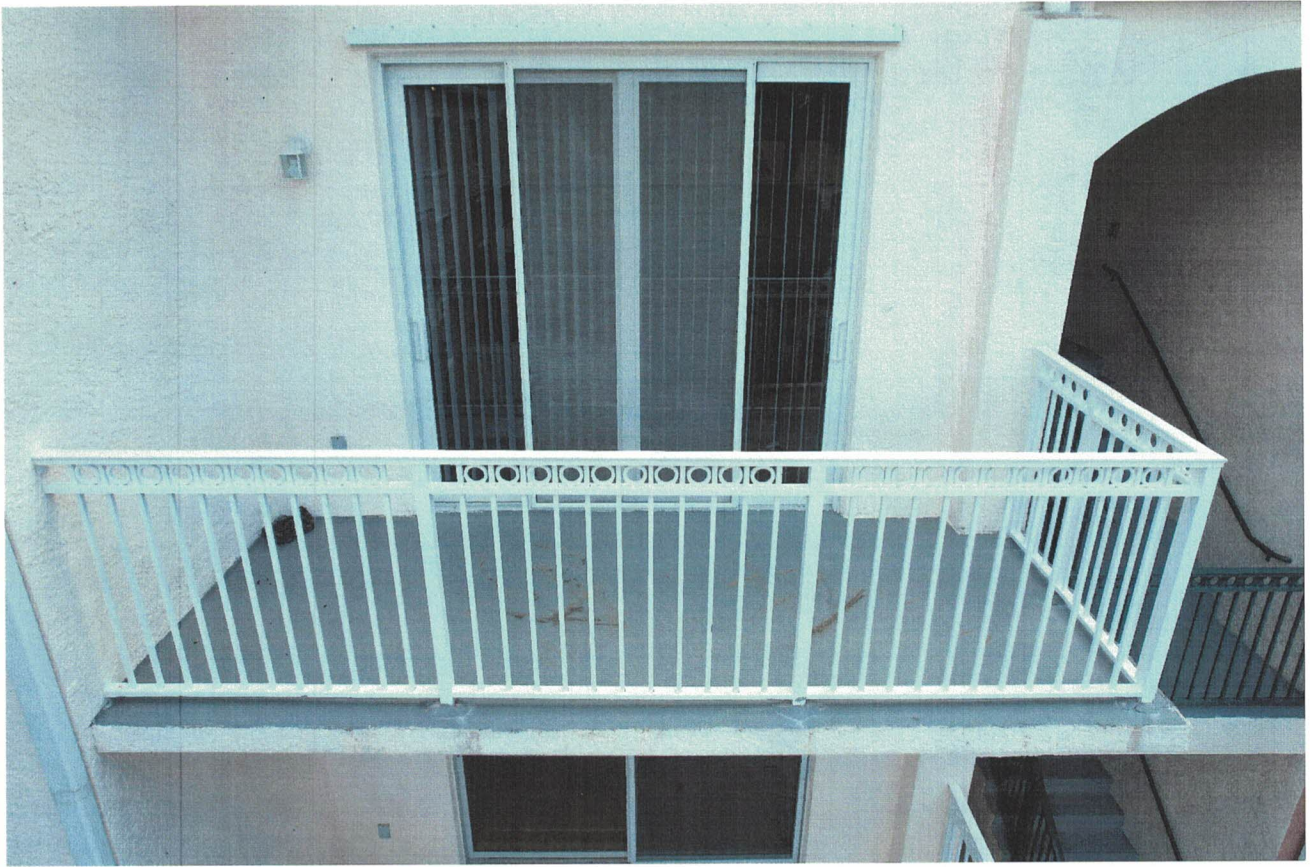
Unit 3310 - Light spalling at base of posts

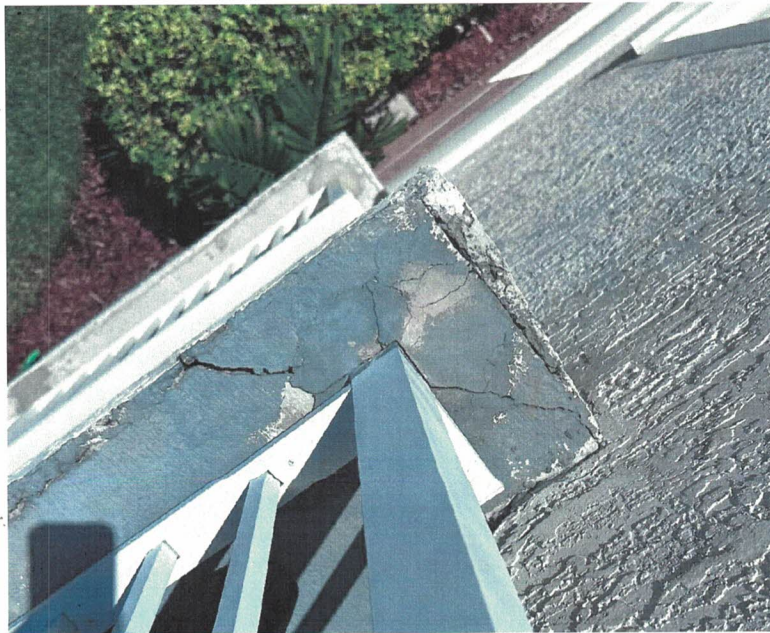
Unit 4302 - Spalling at corner post

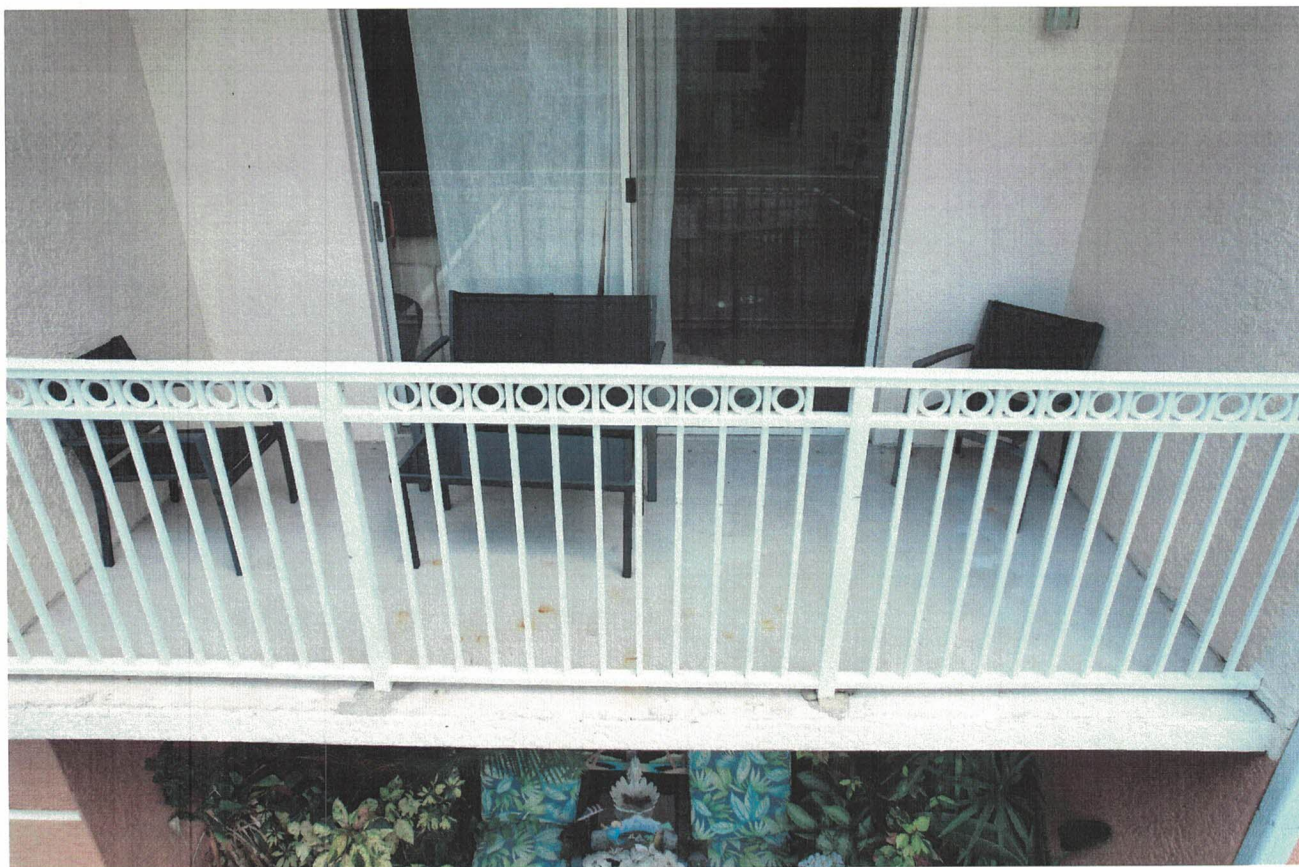
Unit 4202- Light spalling at base of posts

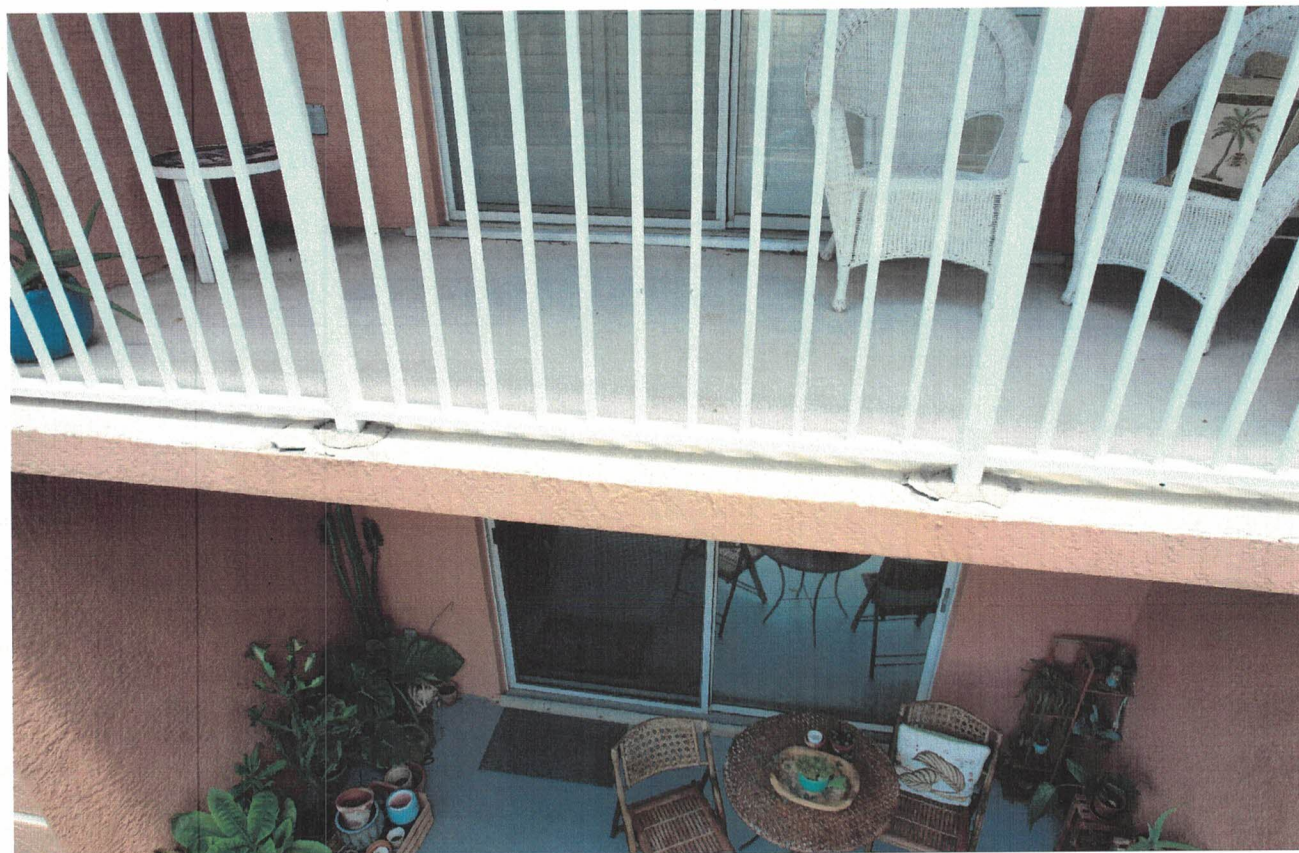
Unit 4204 - Light spalling at base of posts

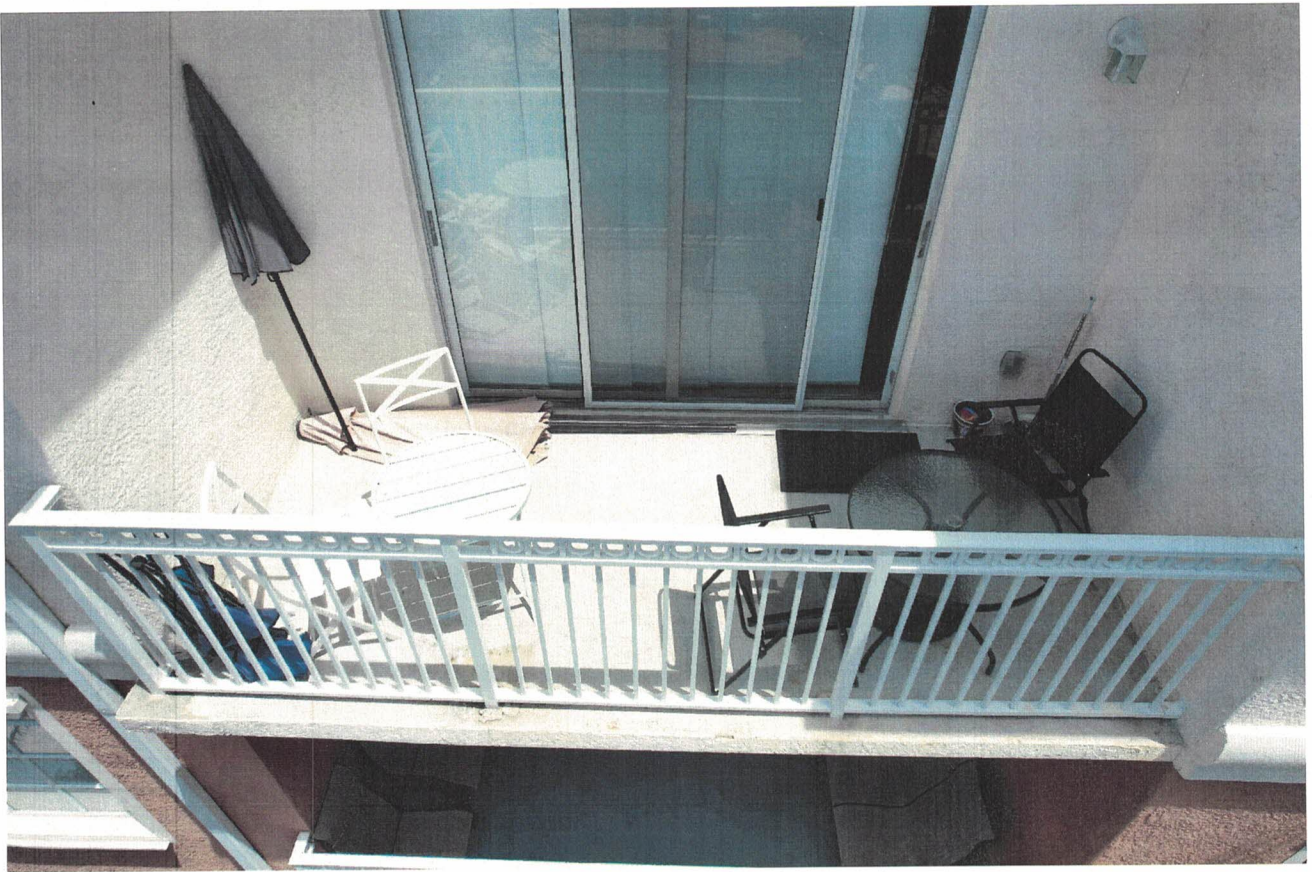
Unit 4306 - Light spalling at base of posts

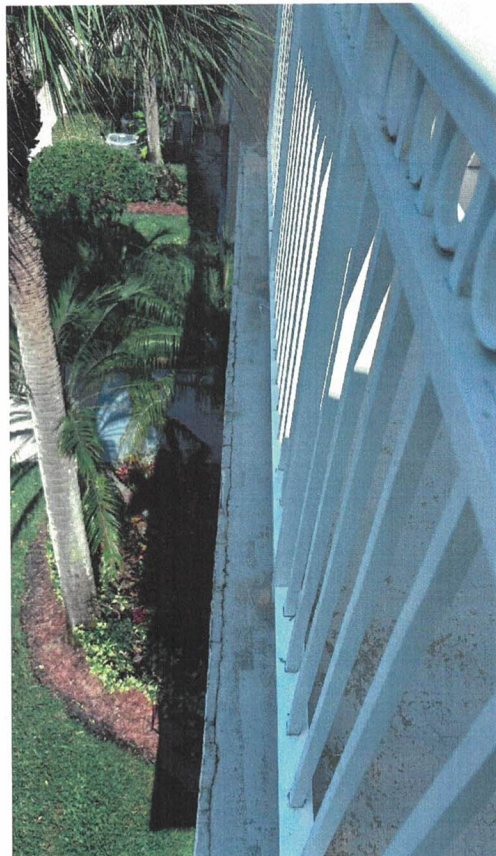
Unit 5302 - Light cracks in stucco

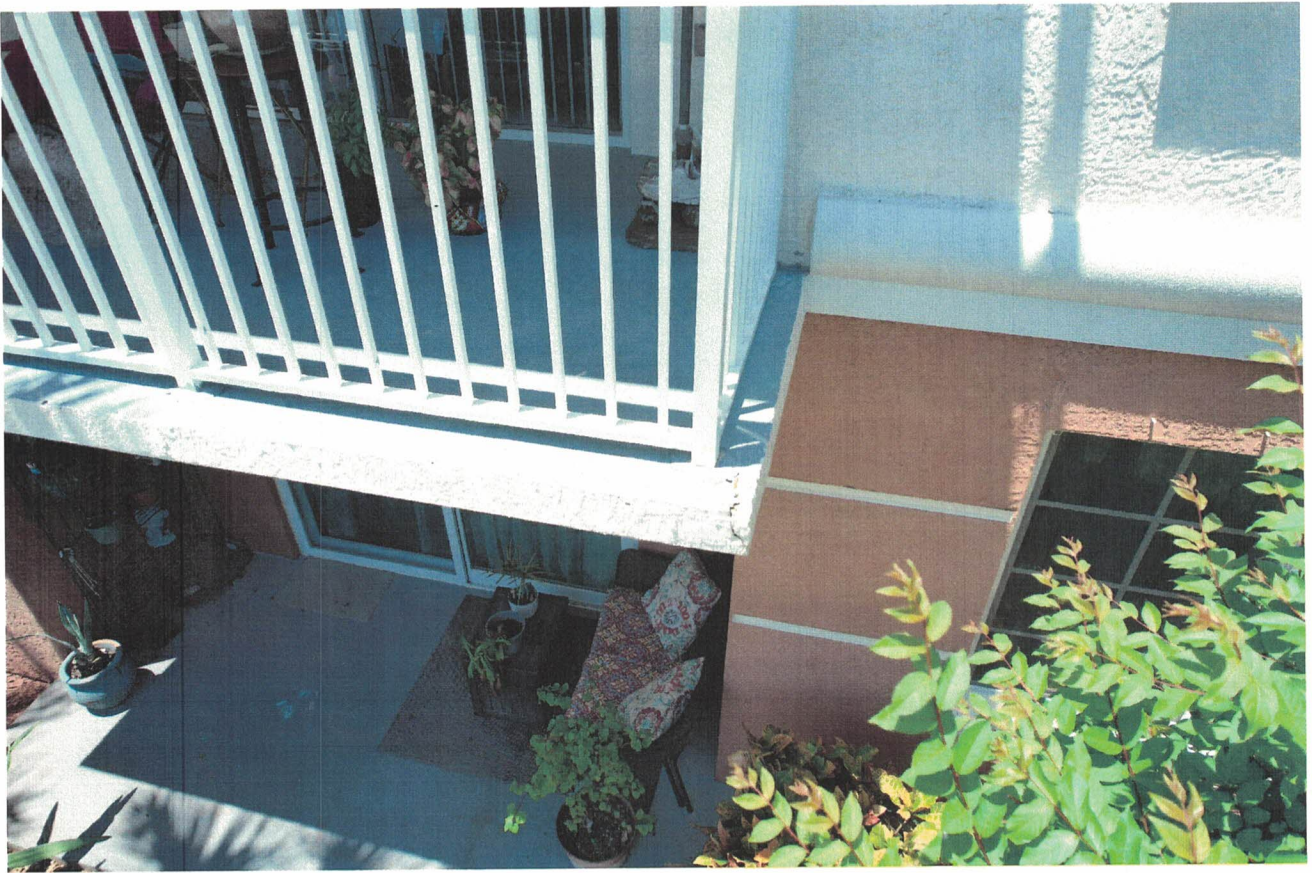
Unit 6202 - Spalling at corner post

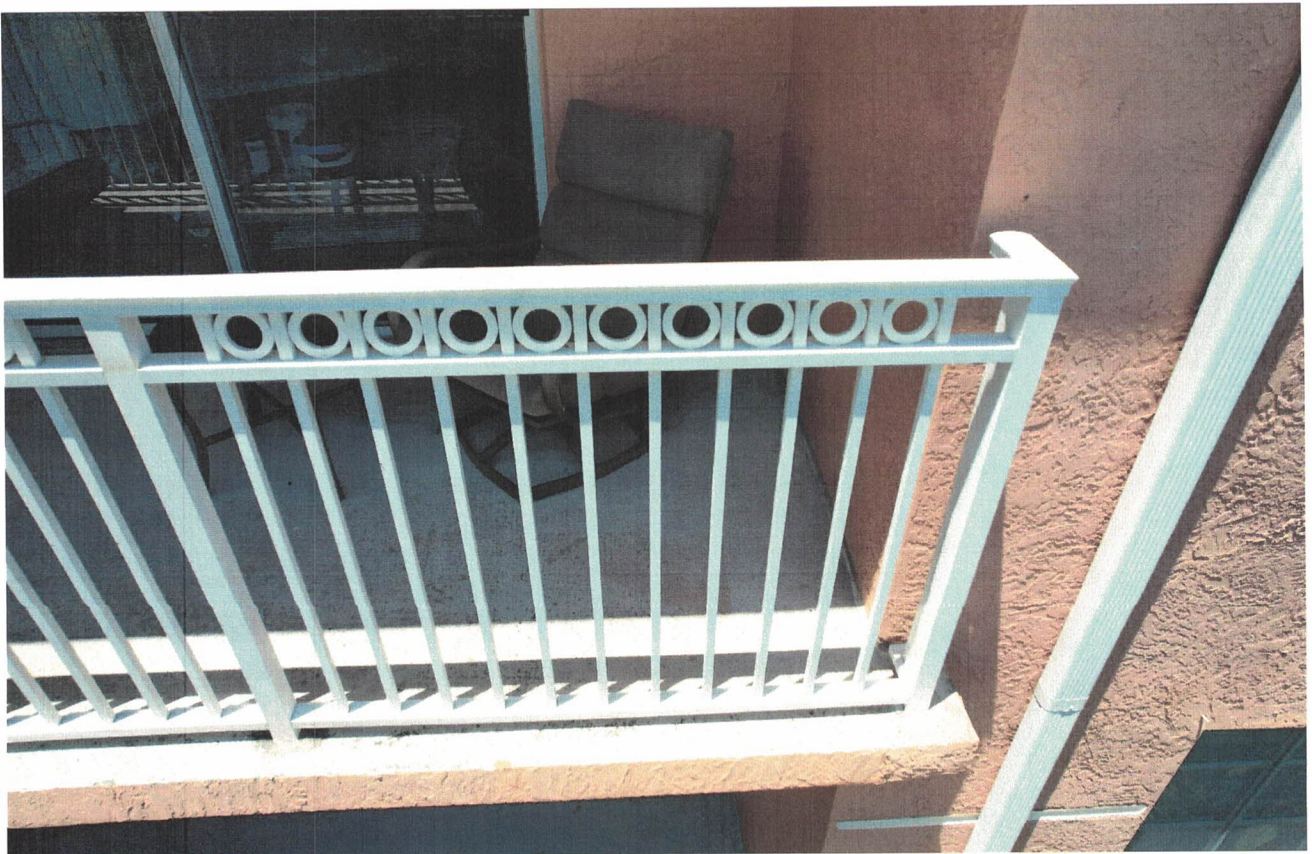
Unit 6204 - Spalling at corner post

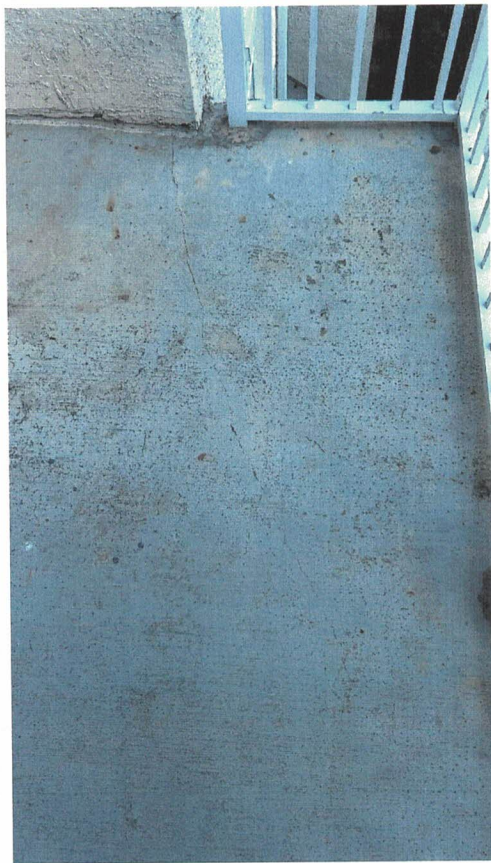
Unit 6308 - Light cracks in balcony slab

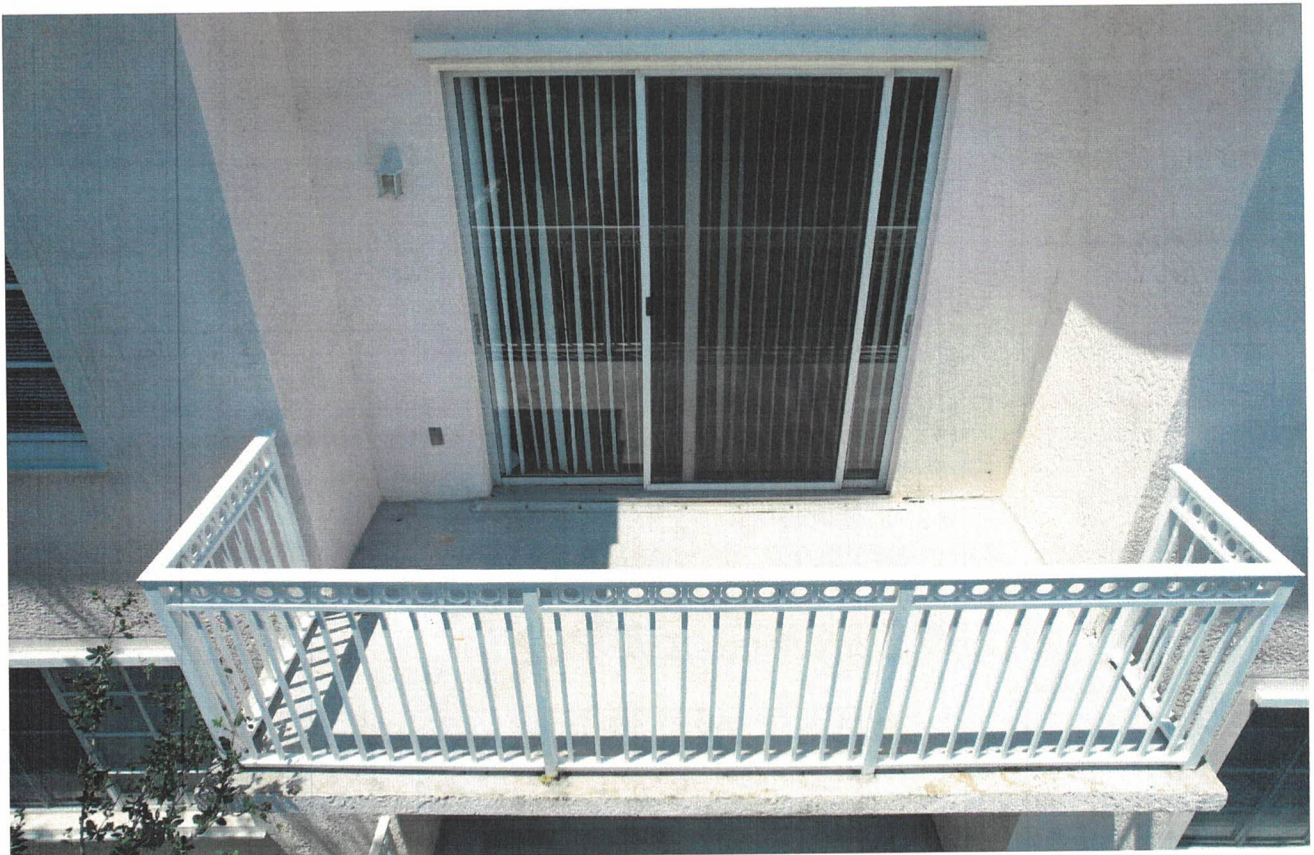
Unit 7308 - Vegetation growing out of the post socket

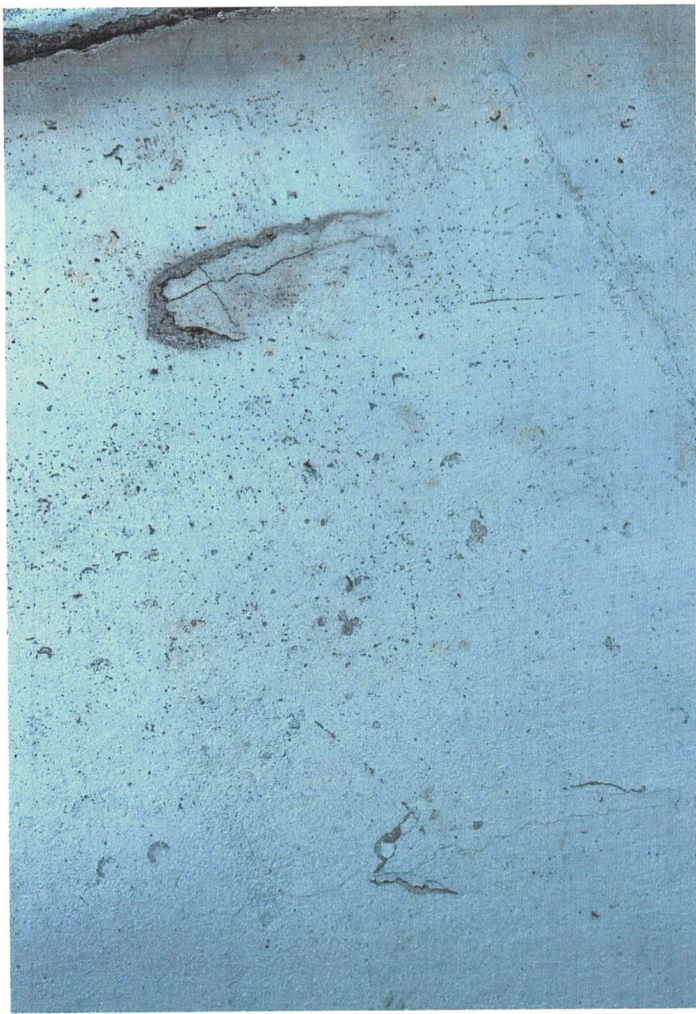
Unit 8206 - Spalling of slab / exposed rebar

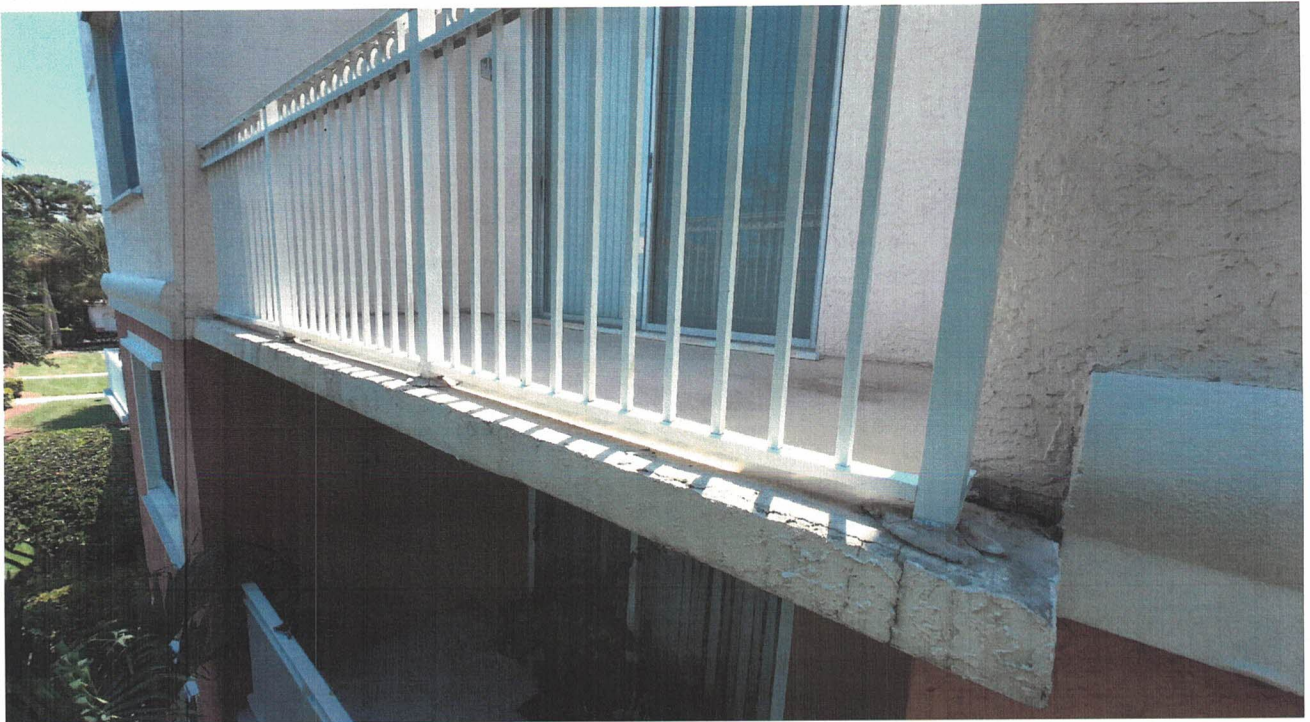
Unit 8310 - Spalling at corner post

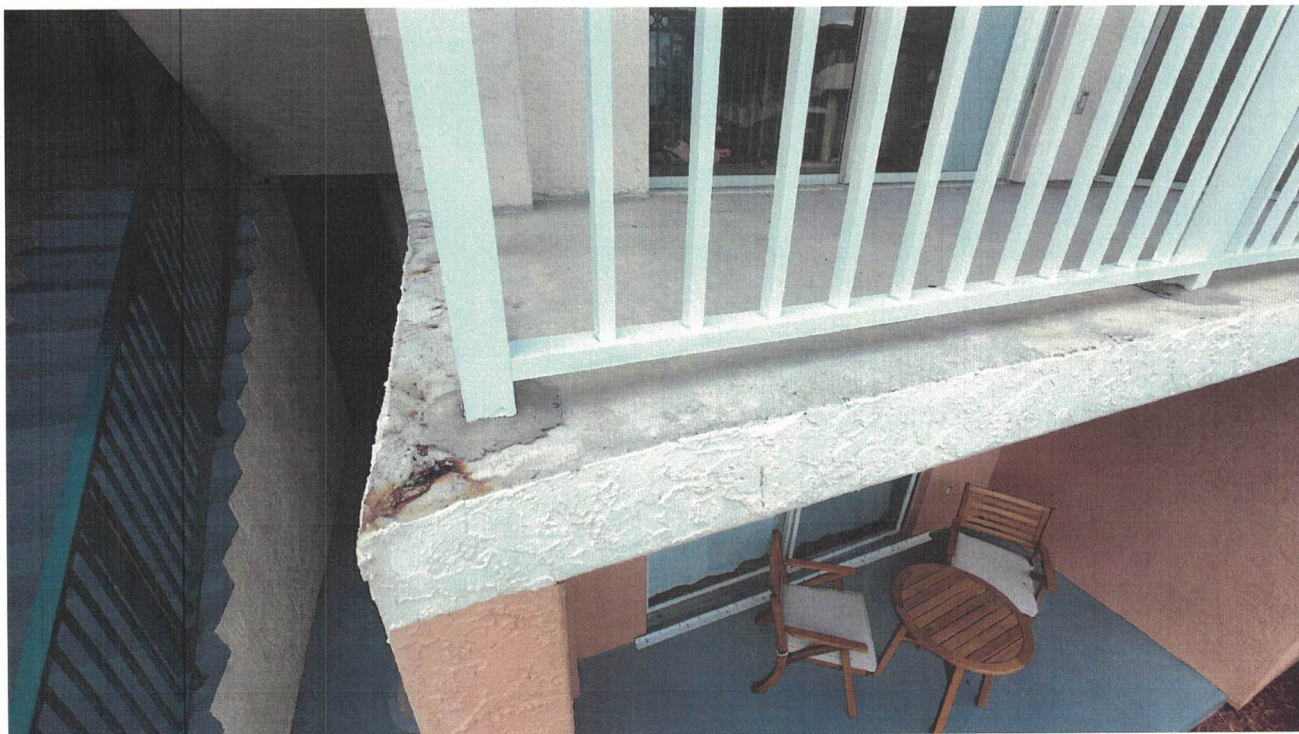
Unit 9204 - Exposed rebar

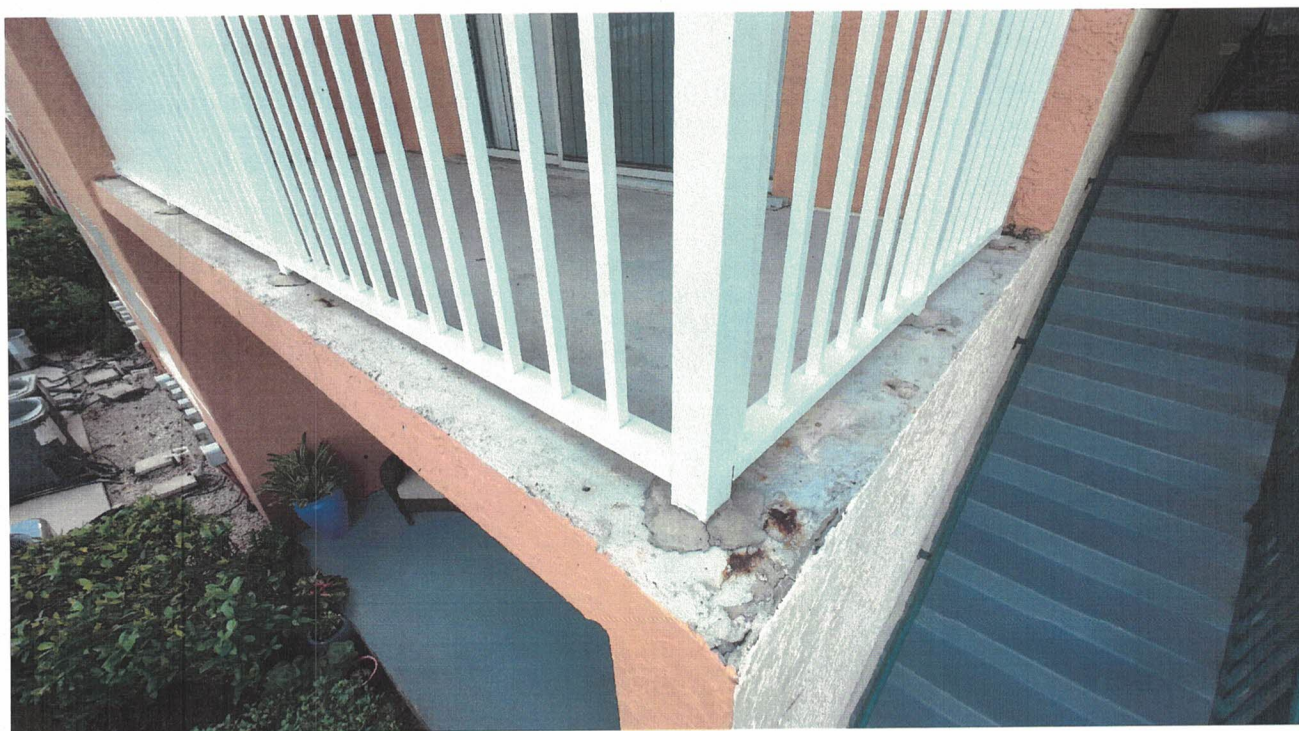
Unit 9206 - Exposed rebar

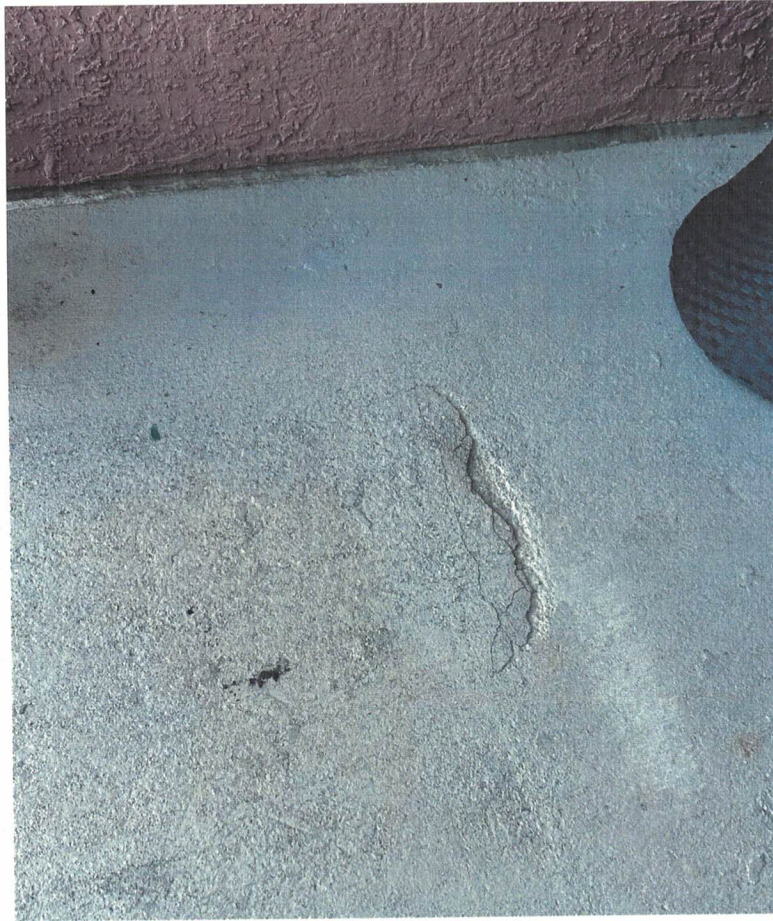
Unit 10206 - Exposed rebar

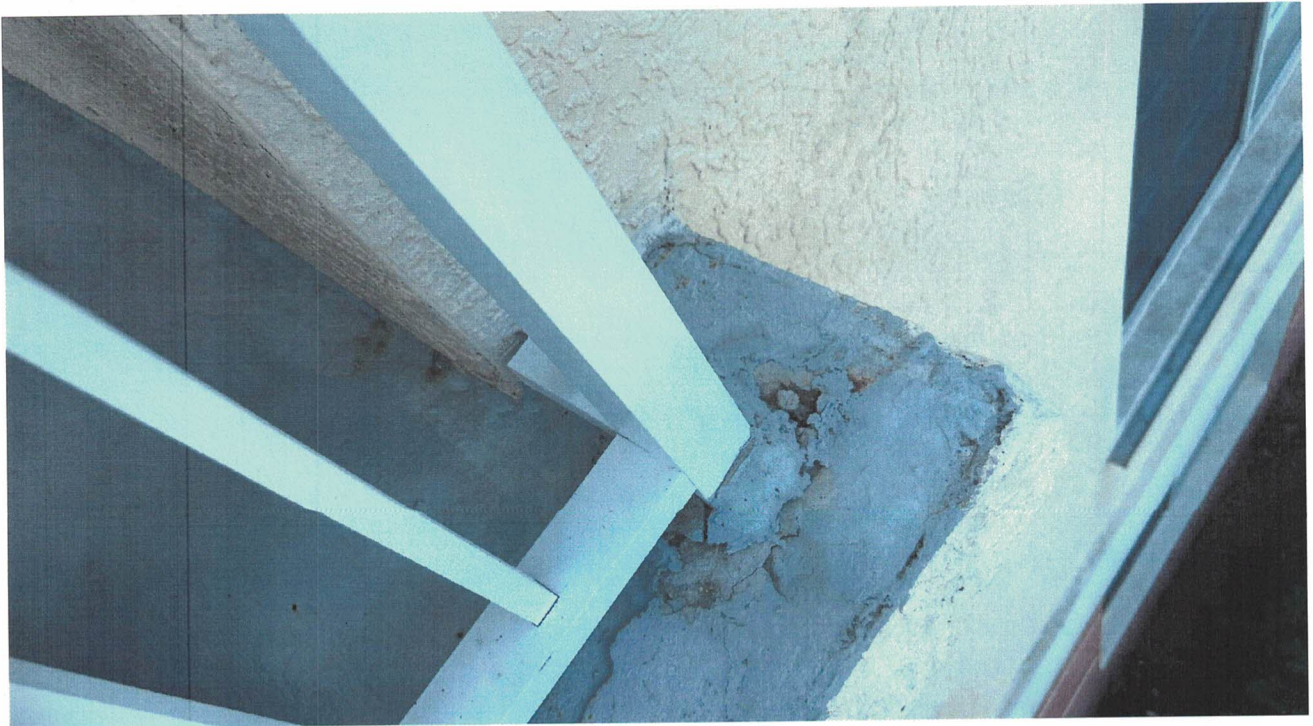
Unit 10308 - Light spalling at posts
